Manhole Inspection Summary

Manhole # S43E__040MH

Insp Date: **6/9/08 11:05 AM**

Location Address: **1515 e fairmount ave**

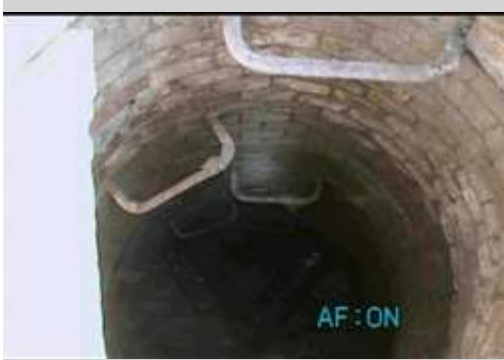
Defect 2

Count: **5** Missing: **0** ☒ **Corroded**

corroded steps

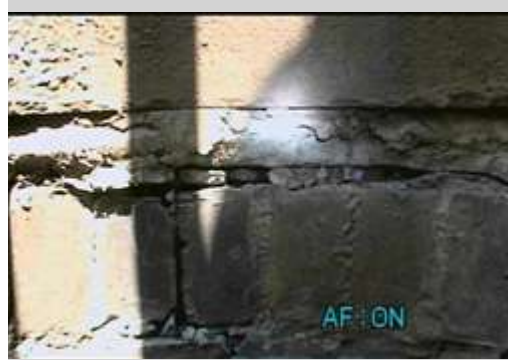
Defect 1

Condition: ☐ Sound ☒ **Cracked** ☐ Root Intrusion ☐ Loose Brick ☐ Deteriorated

Chimney cracked,
frame adj

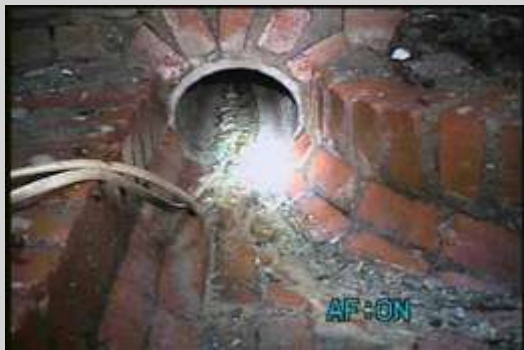
12 O'Clock Outflow

Infiltration: **None** Pipe Seal Cond: **Unknown**

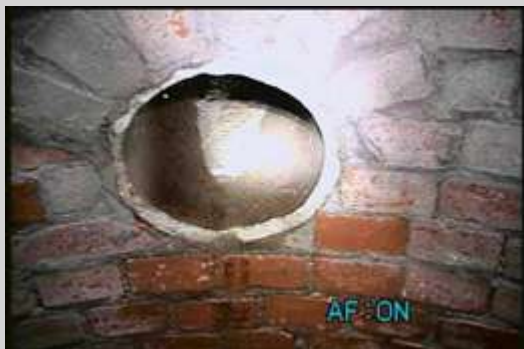
3 O'Clock Inflow

Infiltration: **None** Pipe Seal Cond: **Unknown**

Drop: **Outside Direct**

Drop Condition: **Open**

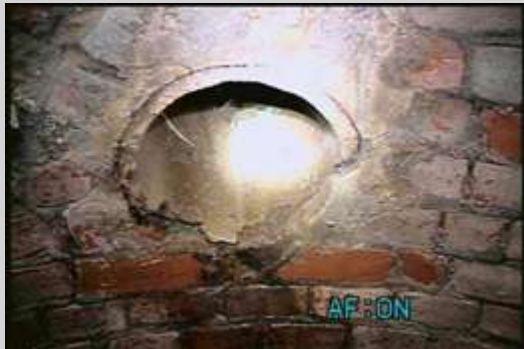
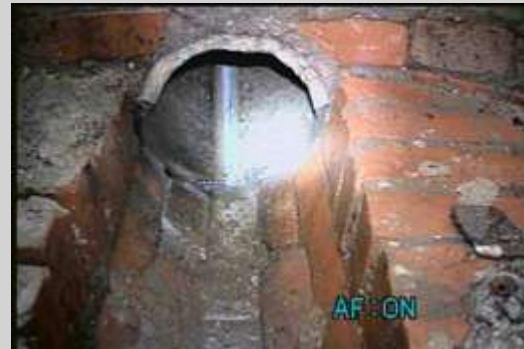
6 O'Clock Inflow

Infiltration: **None** Pipe Seal Cond: **Unknown**

Drop: **Outside** **Direct**

Drop Condition: **Open**
